A 65-year-old female in good health was referred by her dentist to restore both upper laterals due to a history of constant de-bonding. The x-rays of June 1997 revealed an existing metal post loosely cemented (radiolucent space along side the post) in 12, and a large resin with recurrent caries in 22 (Fig. 1). In August 1997, an endodontist completed treatment of 22 (Fig. 2). Evident in the periapical x-ray of this tooth were caries at bone level, a crude angled post form and a resin restoration.

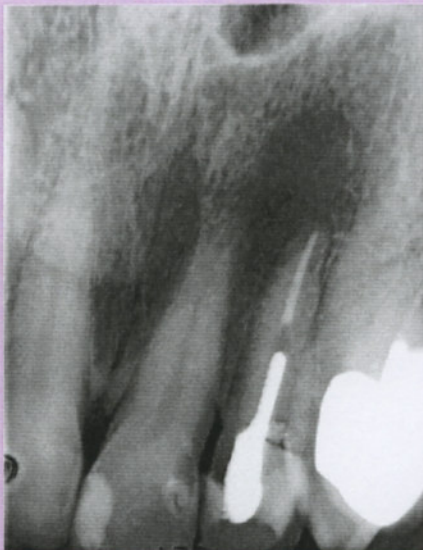
FIGURE 3

By September 1997 tooth 22 showed evidence of a developing periapical lesion, a metal post, a resin restoration and remaining caries (Fig. 3). At the time of the referral, July 1998, both 12 and 22 had been restored with posts and bonded resins and caries still remained in 22 (Fig. 4).

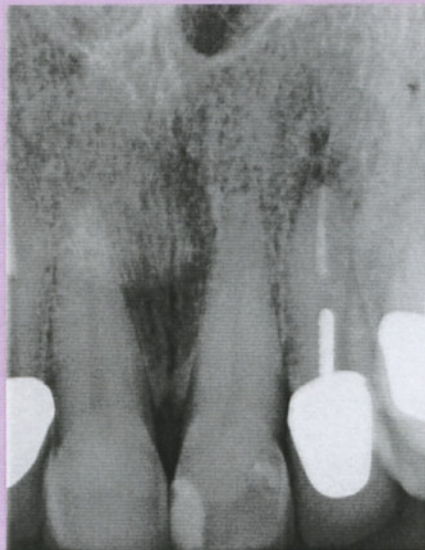
FIGURE 5

Restorative work began with the removal of the metal post in 12 with the aid of ultrasonics and

its replacement with a #1 Composipost, resin core and a PFM crown. Tooth 12 required crown lengthening in order to finish a margin beyond the caries and to create a 2mm ferrule. The metal post in 22 was left behind and a PFM crown was created.
