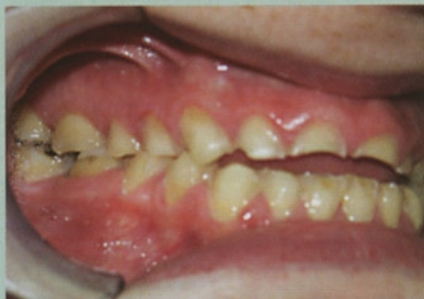
FIGURE 20—Right occlusion – post-treatment.

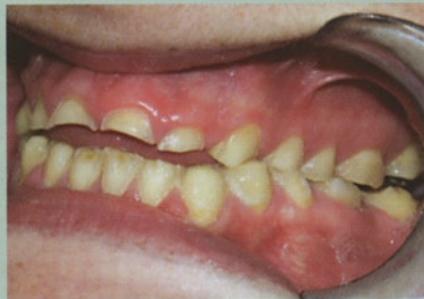
FIGURE 21—Left occlusion – post-treatment.

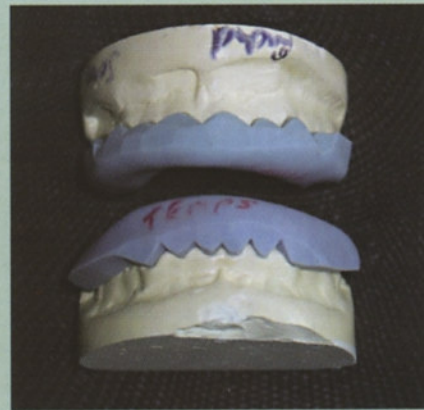
FIGURE 22—Surgical stents – silicone.

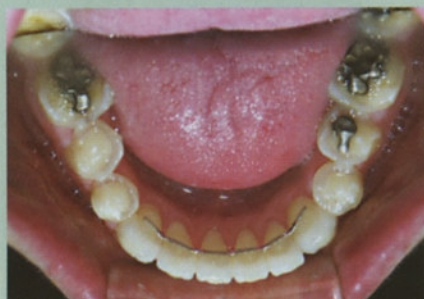
FIGURE 23—Lower anterior – laminates.

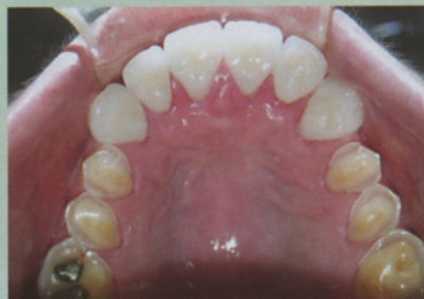
FIGURE 24—Upper anterior – ceramics.

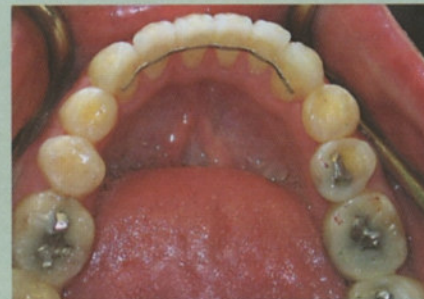
FIGURE 25—Lower complete.

appointment and the patient was seen again eight days later for restoration of teeth 24-27 and 34-37 (Figs 25-28).

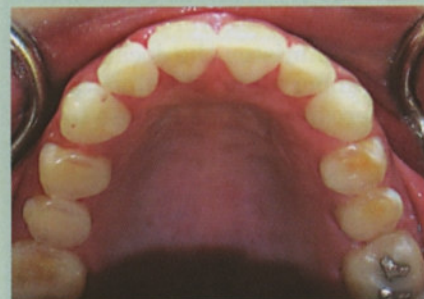
FIGURE 26—Upper final.

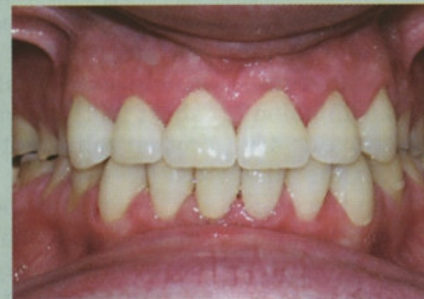
FIGURE 27—Anterior no posterior restorative.

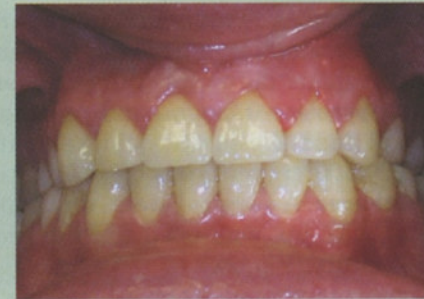
FIGURE 28—Final.
